# Study on the performance variation and failure mechanism of natural gas pipeline under the action of water failure

Hai-Liang Nie <sup>a,\*</sup>, Zhi-Yong Wang <sup>b</sup>, Chen Chen <sup>c</sup>, Wei Dang <sup>a</sup>, Sen Zhao <sup>a</sup>, Jun-Jie Ren <sup>a</sup>, Xiao-Bin Liang <sup>a</sup>, Ke Wang <sup>a</sup>, Wei-Feng Ma <sup>a</sup>

<sup>a</sup> Institute of Safety Assessment and Integrity, State Key Laboratory of Oil and Gas Equipment, CNPC Tubular Goods Research Institute, Xi'an, 710077, Shaanxi, China

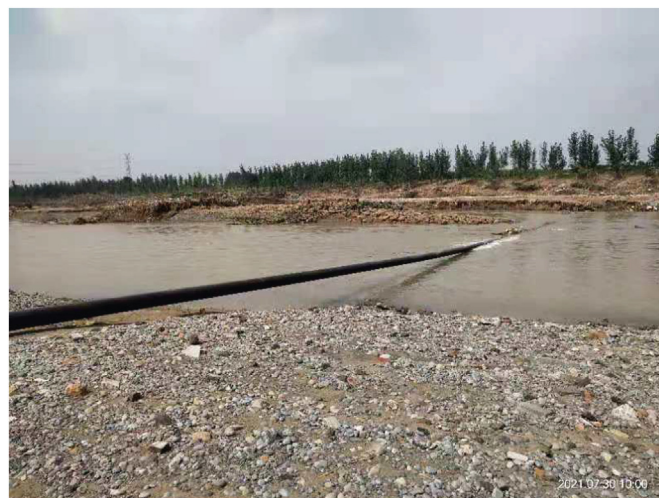
The failure pipe section is directly buried beneath the riverbed pipeline. Due to long-term, extremely heavy rainfall, water erosion occurs in the riverbed, leading to soil loss and causing the crossing pipe to become exposed and suspended, as depicted in Fig. 1. The exposed length of the pipe section is approximately 40 m. The pipe material is L360, the diameter is 273 mm, the wall thickness is 7.1 mm, the design pressure is 4.0 MPa, and the anti-corrosion layer is 3 PE. The pipe employs straight seam resistance welding and features seven welding joints in the water-flushing area. The pipe

Fig. 1. Exposed pipe section after rain erosion.

section has remained in a state of shutdown following water damage. Approximately three months after exposure, the pipe section broke under water erosion at the girth weld near the center point of the suspended span pipe axis.

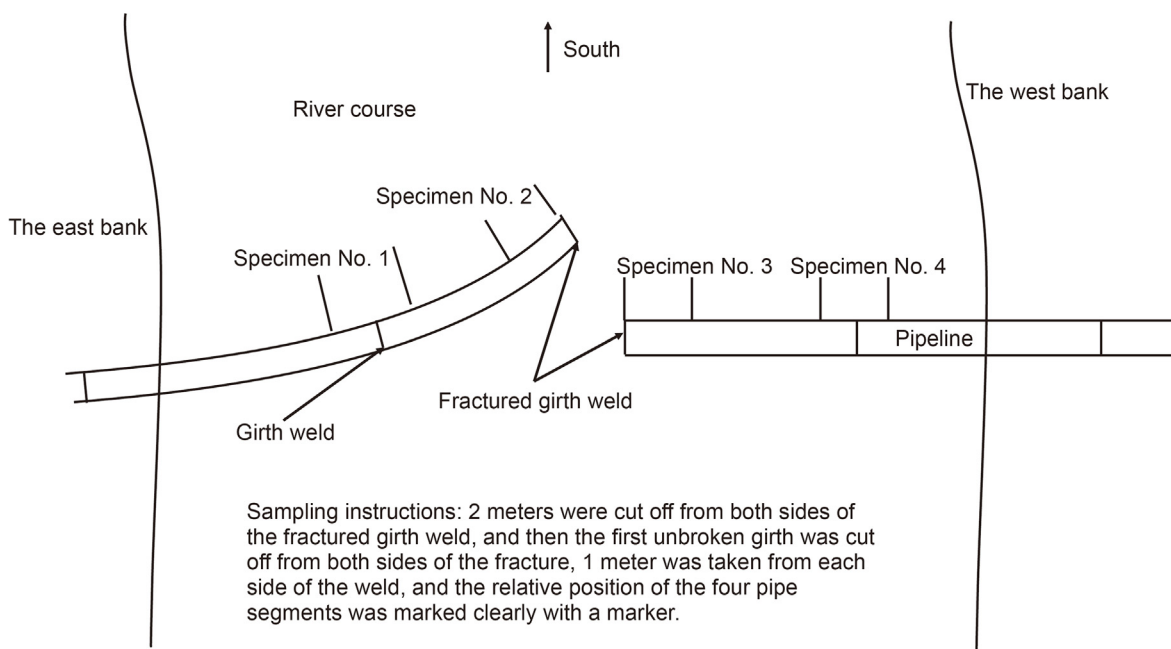
The sampling scheme for field pipe cutting is depicted in Fig. 2. Specimens No.1 and No.4 were taken from the far end of the fracture, each containing an unbroken girth weld. Specimens No.2 and No.3 are pipe segments on both sides of the fracture.

Fig. 2. Sampling scheme of cut pipe.

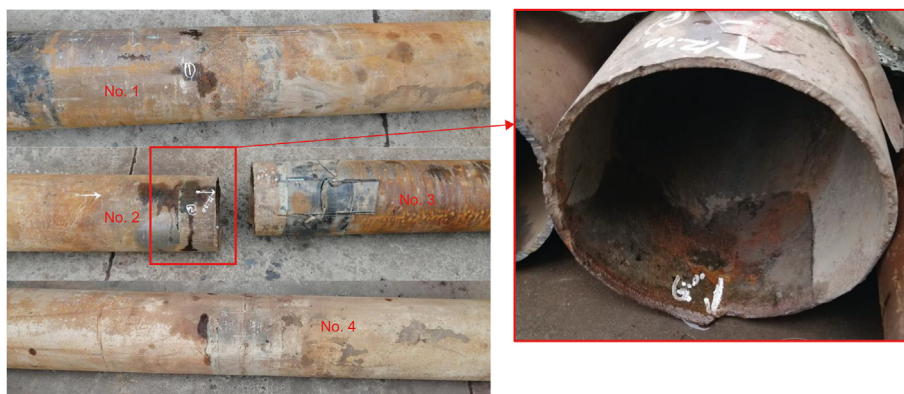
Fig. 3 illustrates the failed pipe segment captured on-site, comprising four pipe segments, each 2 m in length. The anti-corrosion layers on pipe segments No.1, No.2, and No.4 were stripped due to water damage, while the anti-corrosion layer on pipe segment No.3 retains the residual 3 PE layer not stripped at 200 mm from the fracture and extends axially about 300 mm.

The fracture in sample pipe No.2 was observed macroscopically. The fracture between 11:30 and 12:30 was flat and line-free; the fracture between 1:30 and 6:00 exhibited a pronounced crack expansion herringbone pattern, and the fracture was sharp and uneven; the fracture surface between 6:00 and 11:30 was uneven, with many sharp edges and corners. Step-like tear marks were present in the fracture at 6:00.

Fig. 3. Photo of sample pipe.

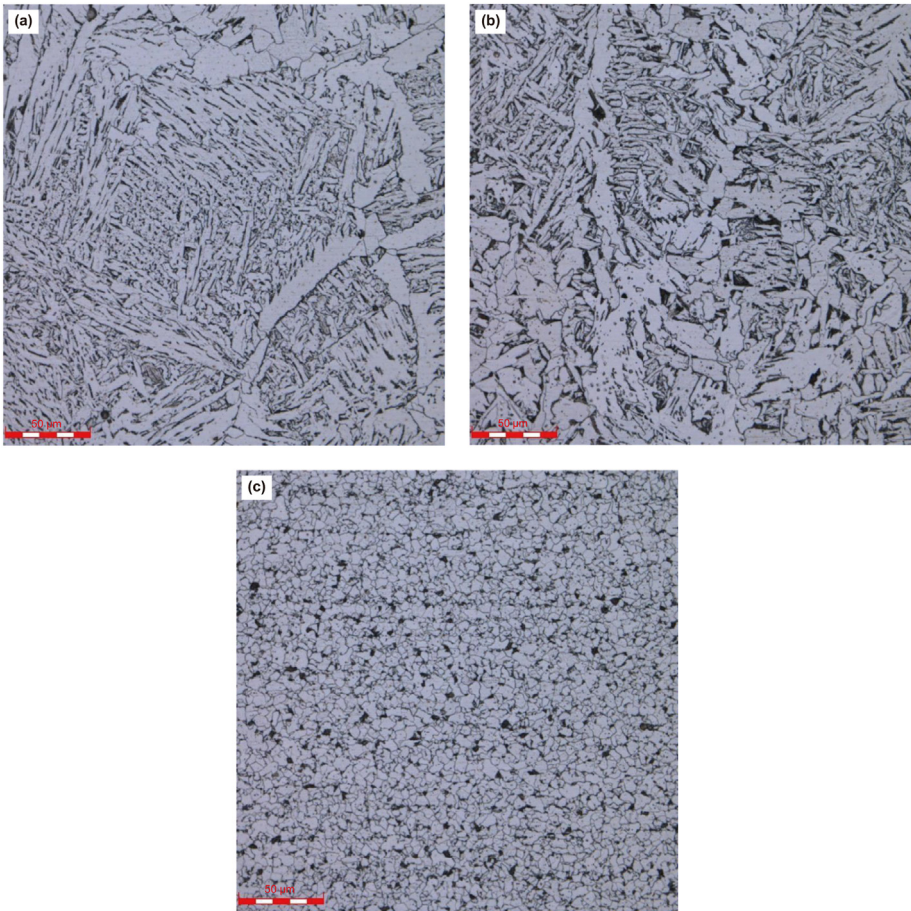
An OLS 4100 laser confocal microscope was employed to analyze the microstructure, grain size, and macrostructure of the girth weld. The microstructure is shown in Fig. 7, and the macrostructure of the weld is depicted in Fig. 8. No obvious abnormalities were observed in the metallographic structure.

**Fig. 7.** Microstructure of girth weld: (a) fusion zone, (b) weld zone, (c) fine-grained zone.

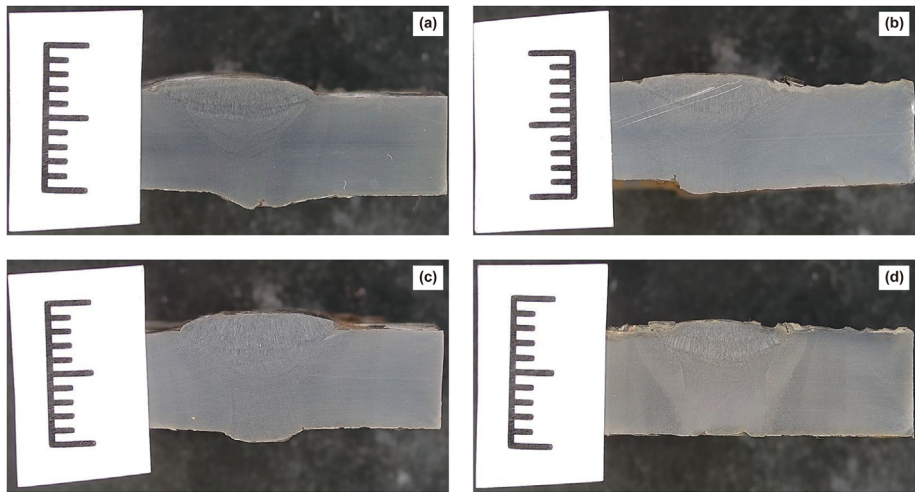
The macro metallography of the girth weld is that the weld cover layer and filling layer consist of 1-pass welding, and the filling layer is 2-pass welding, which meets the requirements of the

Fig. 8. Macro picture of girth weld: (a) 12:00, (b) 3:00, (c) 6:00, (d) 9:00.

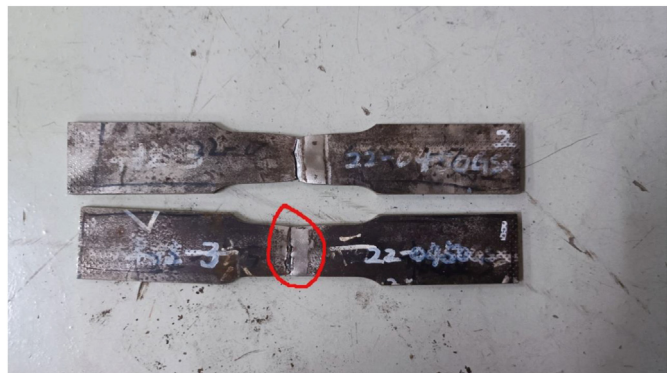
Table 7 compares the mechanical properties of the pipe body base material and the girth weld. This indicates that one sample is fractured in the heat-affected zone (Fig. 9), and its strength is lower than the measured value of the base material. This demonstrates that the strength matching between the girth weld and the base material in the pipe section is not uniform, revealing a localized weak matching phenomenon.

Fig. 9. Photo of girth weld tensile specimen.

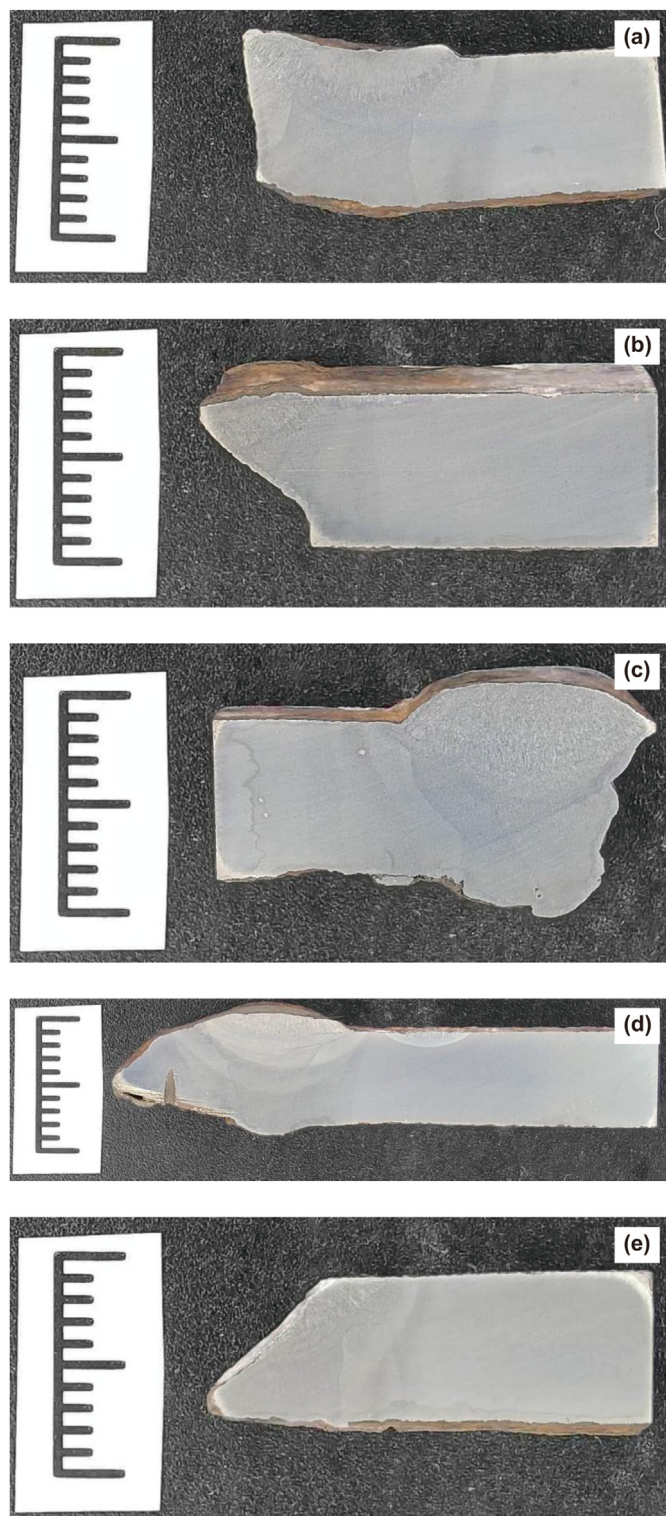
Based on Chinese standards GB/T 13298–2015 and GB/T 4335–2013, an OLS 4100 laser confocal microscope was used to analyze the metallographic structure, grain size, and macrostructure of the weld at the fracture girth. The results of the metallographic structure analysis are listed in Table 8, and the macrostructure of the weld is shown in Fig. 10. The acronyms in Table 8 are as follows: “P” represents pearlite, “PF” represents polygonal ferrite, “Bgranules” represents granular bainite, “IAF” represents intracrystalline nucleation acicular ferrite, “MA” represents martensitic austenitic island structure. No abnormalities were observed in the metallographic structure, and misalignment defects were found at positions 5:30 and 8:00.

Fig. 10. Metallographic picture of girth weld fracture: (a) at 12:00, (b) at 2:30, (c) at 5:30, (d) at 8:00, (e) at 10:30.

The metallographic diagram of the girth weld at the fracture shows that the fracture initially cracks at the weld toe of the cover layer on one side of the girth weld between 11:30 and 12:30 under vibration. The crack then progressively penetrates the weld along

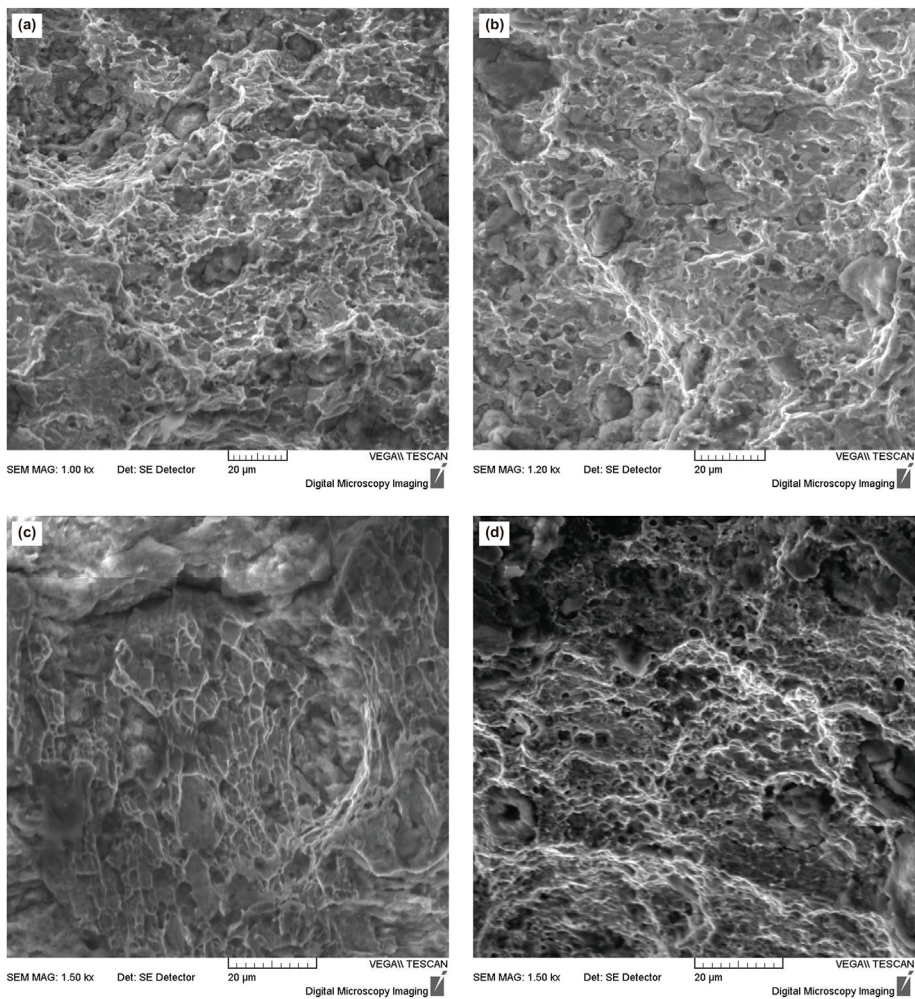
The SEM results of the fracture are depicted in Fig. 11. Since the pipe section was exposed to water erosion for a long time after fracturing, corrosion has occurred at the fracture site. Despite several cleanings, corrosion products cannot be removed at some fractures.

Fig. 11. Typical micromorphology of fracture specimen surface: (a) at 12:00, (b) at 2:30, (c) at 5:30, (d) at 8:00.

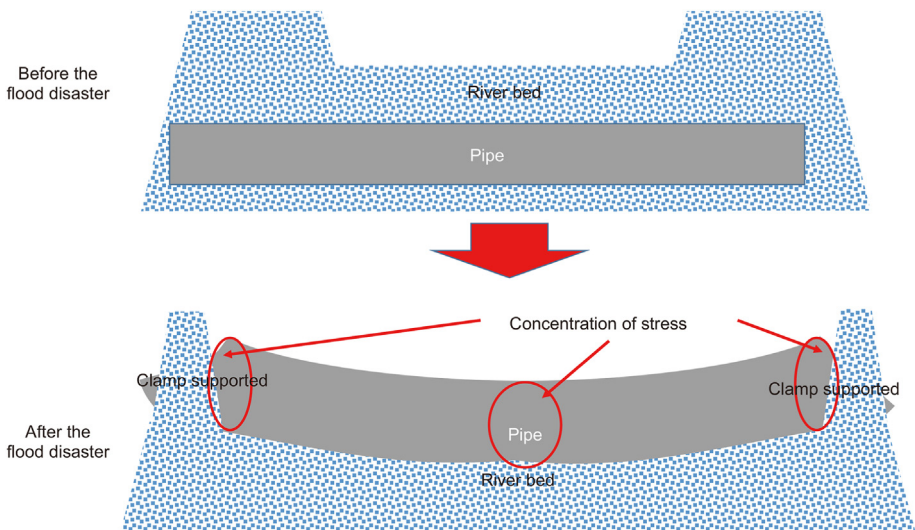
Data investigation reveals that the pipe section was originally a riverbed crossing pipe section with a buried depth of about 3–4 m. The river is a seasonal river, typically shallow and narrow. Due to prolonged rainstorms, the water level surged, and the flood erosion gradually lowered and widened the riverbed, eventually exposing the buried pipe section and altering the laying condition from the original riverbed crossing to a new riverbed crossing scenario.

and pipe system maintained a static equilibrium. The forces on the pipe section were uniformly distributed, with no stress concentration. However, the flood-induced erosion of the riverbed has caused the river channel to widen and deepen, exposing the pipe section and transforming its structure into a typical double

Fig. 12. Schematic diagram of the structure and stress changes of the pipeline crossing the river before and after the flood disaster.

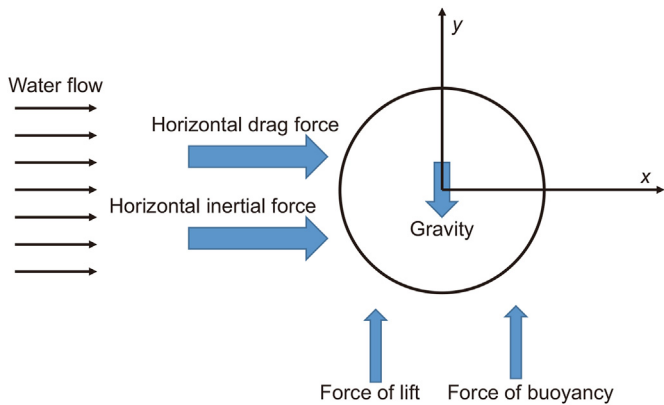
During a flood, the pipeline experiences the combined effects of loads such as hydrodynamic force, buoyancy, and the resistance of the pipe body and soil foundation (Zhang et al., 2006), as depicted in Fig. 13.

Fig. 13. Schematic diagram of load-bearing condition of flood pipeline.

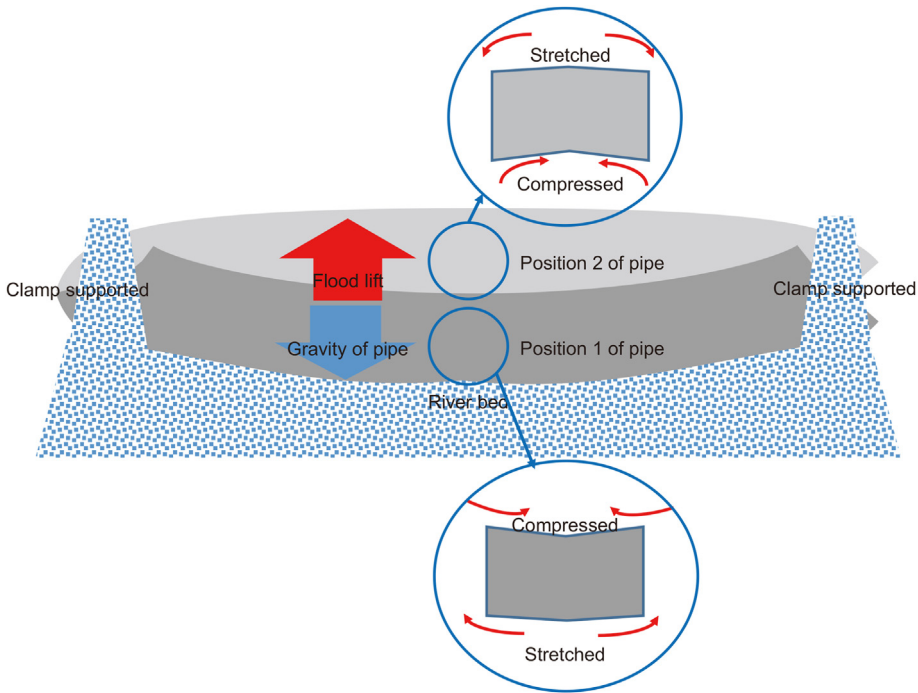
This analysis indicates that under the influence of flood erosion and the pipeline's gravity, the local pipeline endures cyclic stretching and compression stresses. However, from the actual vibration process of the pipeline, it is observed that the curvature of the lifting and sinking is asymmetrical, with the sinking curvature being larger, thus subjecting the local pipeline to cyclic loads of asymmetric stress. Under the load, the material's mechanical properties are affected, and these changes manifest as a ratchet effect in strain, a Bauschinger effect in stress, and cyclic hardening in hardness.

Fig. 14. Schematic diagram of pipeline deformation and stress changes under flood erosion and the action of the pipeline's own gravity.

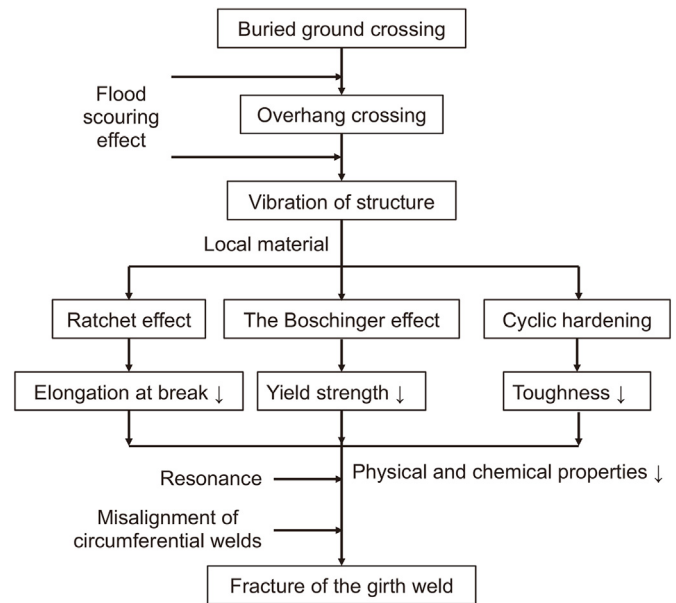
The above analysis shows that the water pipe section failed due to various interacting factors. The main failure process is as follows: flood-induced water and soil erosion expose the pipeline on the riverbed, changing its status from a buried to a suspended crossing. The suspended pipeline vibrates due to its weight and flood impact. This vibration induces a reciprocating cyclic load of stretching and compression near the axial midpoint of the pipe. Under the ratchet effect, the elongation at the break of the material decreases; under the Bauschinger effect, both the yield strength and yield ratio decrease. Cyclic hardening further reduces the impact of the toughness of the material. Calculations show that the natural frequency of the suspended span pipe structure is approximately 18.89 Hz. At this frequency, the vibration amplitude of the pipe section is most intense, eventually causing the annulus weld near the axial midpoint to break. The failure process is illustrated in Fig. 18.

Fig. 18. Schematic diagram of pipeline fracture process.

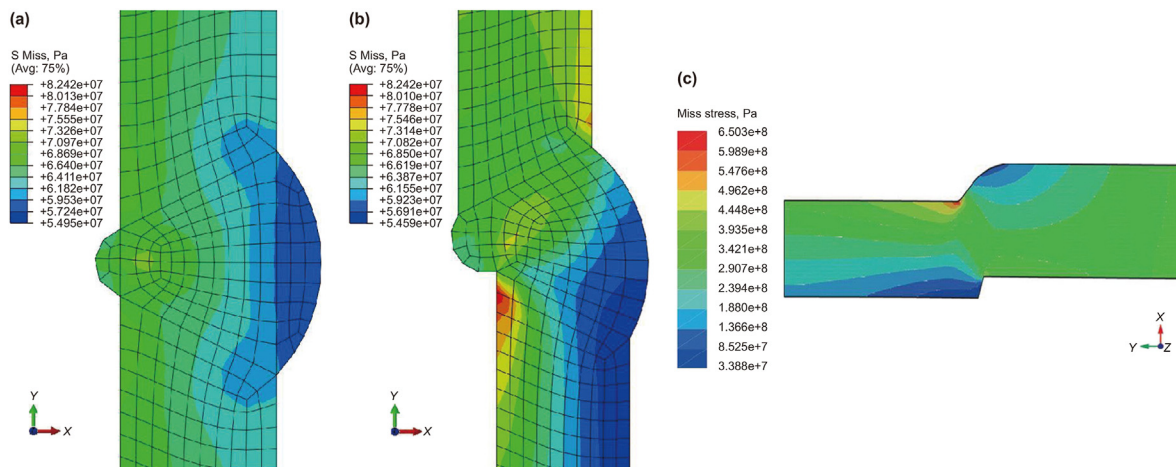
Based on the results of metallographic observation, both the unbroken and broken girth welds of the pipe section have misalignment defects. According to the provisions of Welding Evaluation, these edge defects do not exceed the standard.

This study utilizes ABAQUS simulation to illustrate the influence of misalignment on the stress distribution of girth welds. The model replicates the same pipe as that studied herein, with an external diameter of 237 mm, a wall thickness of 7 mm, and an internal pressure of 4 MPa. The normal weld and the weld with misalignment were simulated, respectively, and the amount of misalignment was set to 2 mm. The simulation results are shown in Fig. 17(a) and (b). It can be seen that, compared to the normal weld, the weld with misalignment will have obvious stress concentration at the toe of the weld, which is consistent with the simulation results in the literature (Li et al., 2021) (as shown in Fig. 17(c)).

Fig. 17. Stress concentration of the girth weld caused by the misalignment: (a) normal girth weld, (b) girth welds with misalignment, (c) simulation results of girth welds with misalignment in the literature (Li et al., 2021).

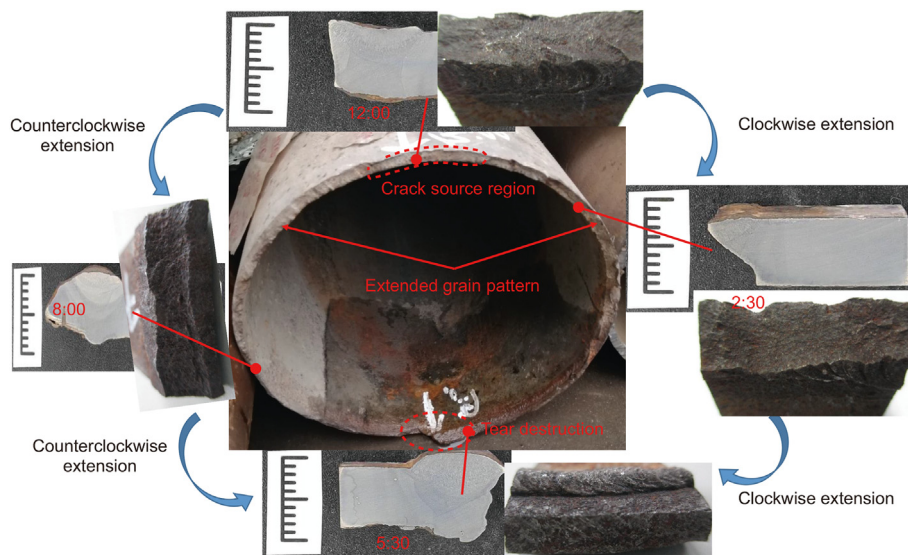
the heat-affected zone. In the clockwise direction, as the clock position increases, the crack expands from one side of the heat-affected zone to the center of the weld and spreads to the opposite side of the heat-affected zone around 6:00. The stress concentration shifts and the crack distribution within the wall thickness also develops from one side of the heat affected zone to the other. In contrast, as the clock position decreases, the crack extends along one side of the heat-affected zone in the counter-clockwise direction and finally into the base material. When the crack reaches about 6:00, it fully enters the base material. The cracks from both directions intersect at 6:00. Due to the incomplete alignment of the two crack paths, there are only a few connections within the pipe body at 6:00, which eventually tear apart and break under the stress of vibration, resulting in a step-like fracture. The fracture process is depicted in Fig. 19.

Fig. 19. Schematic diagram of the fracture process of the pipeline.
