# Study on the performance variation and failure mechanism of natural gas pipeline under the action of water failure

Hai-Liang Nie <sup>a,\*</sup>, Zhi-Yong Wang <sup>b</sup>, Chen Chen <sup>c</sup>, Wei Dang <sup>a</sup>, Sen Zhao <sup>a</sup>, Jun-Jie Ren <sup>a</sup>, Xiao-Bin Liang <sup>a</sup>, Ke Wang <sup>a</sup>, Wei-Feng Ma <sup>a</sup>

<sup>a</sup> Institute of Safety Assessment and Integrity, State Key Laboratory of Oil and Gas Equipment, CNPC Tubular Goods Research Institute, Xi'an, 710077, Shaanxi, China

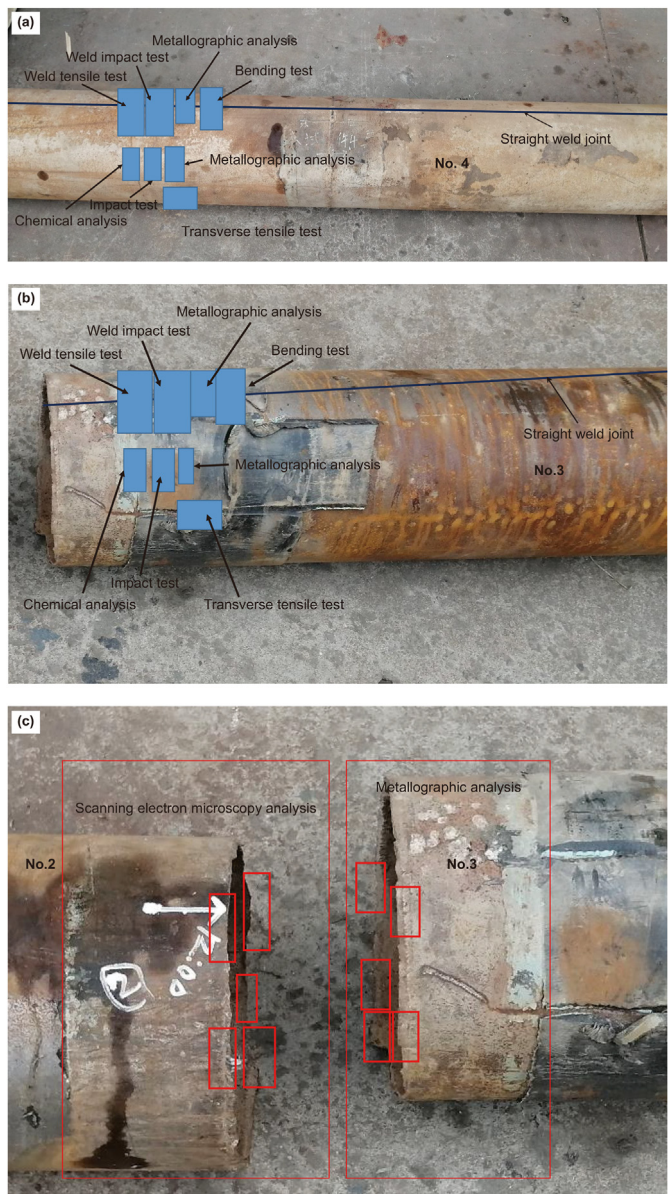
chemical composition, tensile properties, and Charpy impact properties of the base material of pipe section No.4 were sampled, and tensile properties, Charpy impact properties, metallographic properties, and bending properties of the straight weld were examined. The sampling position on pipe section No.4 is illustrated in Fig. 5(a).

The pipe body and straight weld at the edge of the fracture were sampled and analyzed. The sampling position is shown in Fig. 5(b).

The fracture parts of sample pipes No.2 and No.3 were sampled and analyzed. The sampling positions are shown in Fig. 5(c). Five areas (at clock positions of 12:00, 2:30, 5:30, 8:00, and 10:30) with uneven, sharp, and tearing marks were selected for sampling and analyzed by metallography and a scanning electron microscope to observe the microscopic morphology of the fracture.

**Fig. 5.** Schematic diagram of sampling position: (a) sampling of physical and chemical properties of pipe body and straight seam of pipe section No.4, (b) sampling position of pipe body and straight weld at fracture edge of pipe section No.3, (c) sampling position at fracture.

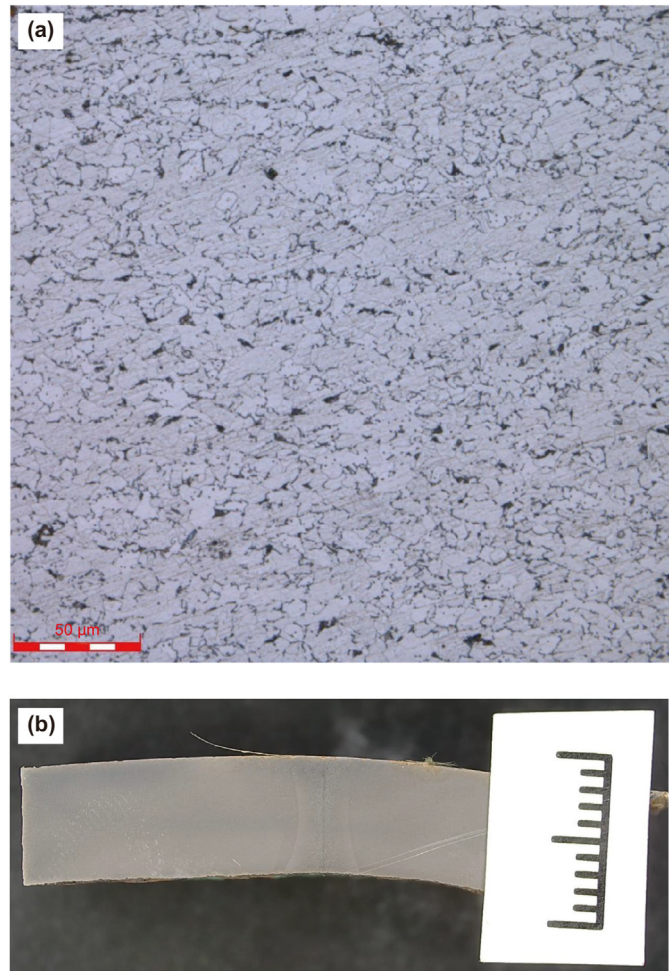
An OLS 4100 laser confocal microscope was employed to analyze the straight weld's metallographic structure and grain size. The metallographic structure is illustrated in Fig. 6(a), and the macroscopic appearance of the straight weld is displayed in Fig. 6(b). There were no abnormalities in the metallographic structure or

macroscopic welding defects in the straight weld.

**Fig. 6.** Image of pipe structure: (a) metallographic structure, (b) weld macrostructure.

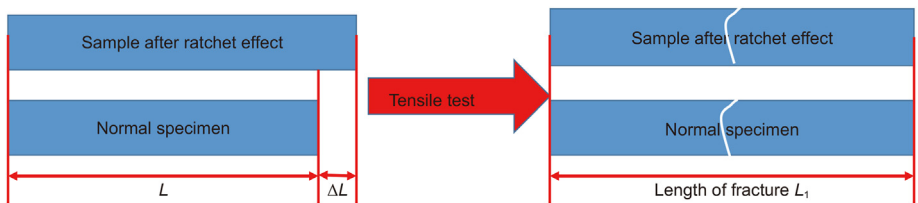
This process repeats when the pipe section is impacted by water flow, leading to the ratchet effect in the material. The ratchet effect results in cyclic accumulation of plastic strain, reducing the material's resistance to destructive strain (Paul et al., 2011a, b, c; Lin et al., 2013).  
Because the ratchet effect can cause the accumulation of residual plastic deformation in materials, the initial length of the sample includes residual strain when the part affected by the ratchet effect is sampled for a tensile test. Fig. 15 indicates that the tensile sample is taken near the area affected by the ratchet effect, and the length is  $L+\Delta L$ , where  $\Delta L$  is the accumulation of deformation caused by the ratchet effect. The normal sample length should be  $L$ , and when the sample is stretched to break, the length becomes  $L_1$ . For the specimen affected by the ratchet effect, its elongation at break is significantly reduced.

Fig. 15. Schematic diagram of failure strain reduction caused by the ratchet effect.

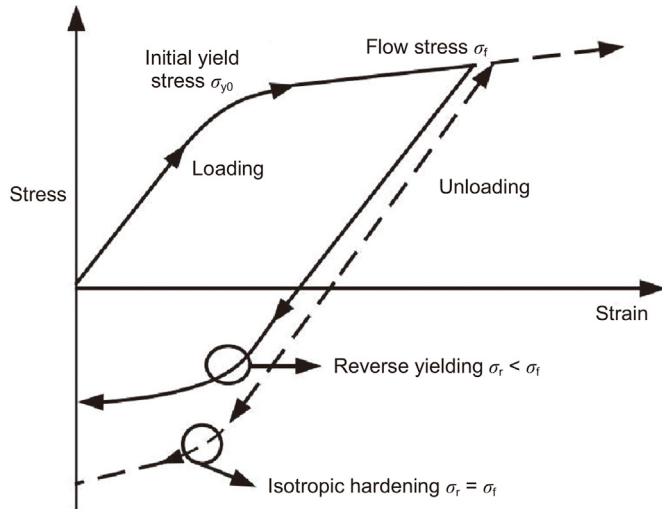
In a series of tensile and compression experiments on steel conducted by Bauschinger (1881), the yield point of the material decreased during reverse deformation, i.e., after experiencing a certain amount of one-way tensile or compressive plastic deformation followed by reverse loading, the yield stress of the material was lower than the yield stress of continuous forward deformation. This phenomenon, known as the Bauschinger effect (Xie et al., 2019; Guo et al., 2020; Wang et al., 2020), is illustrated in Fig. 16. Under the impact of water flow, the midpoint of the suspended span section of this failed pipe section repeatedly experiences the Bauschinger effect.

Fig. 16. The stress-strain diagram of the Bauschinger effect.
